Removal of 11 Laminate Veneers with Er-Yag Laser

Case Report

The objective of this study is to report a clinical case of debonding and removal of 11 ceramic laminates with the technology of Er:YAG laser, with controlled application time for pieces debonding, patient comfort and remaining structure conservation.

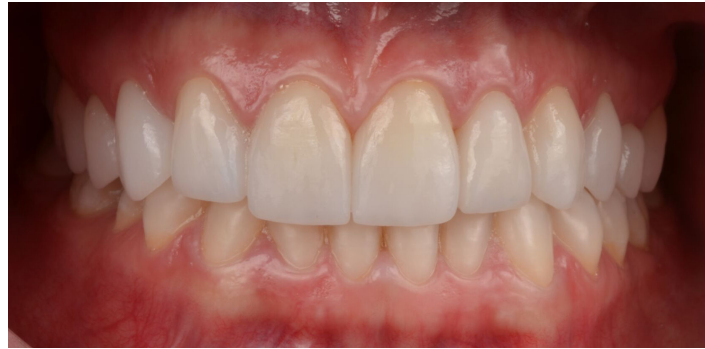
The patient had 11 previously cemented laminated ceramics, from the upper arc's first molar on the right side to the first molar on the left. The patient presented agenesis of element #12. The veneers consisted of pressed lithium disilicate, colour W1, HT pressing ingots (Rosetta-Hass, Gangwon-do, South Korea) and cemented with self-curing cement (Variolink Esthetic, Ivoclar Vivadent-Schaan, Liechtenstein). The etching was performed with 5%-hydrofluoric acid (CEtching, BM4 - Santa Catarina, Brazil) for 20 s, followed by rinsing with water, decontamination in the ultrasonic cleaner with alcohol at 70% for 5 min and water rinsing. After drying of pieces, silane was applied (Primer Monobond N Universal-Ivoclar Vivadent, Schaan, Liechtenstein), followed by warm air jets for 1 min on each side of the drying device of ceramic laminates. So, a thin layer of a universal adhesive (T-Tric N-Bond Universal - Ivoclar Vivadent, Schaan, Liechtenstein) was applied, followed by air jet. On the tooth, 20 sec 37%-phosphoric acid conditioning was performed (Ultradent - Utah, USA), followed by water/air spray cleaning. After drying with absorbent paper, the universal adhesive was used (Tetric N-Bond Universal-Ivoclar Vivadent, Schaan, Liechtenstein), after light air jet drying. The soft coloured light-curable cement (Variolink Esthetic - Ivoclar Vivadent) was applied on the ceramic laminate, and the set was positioned. After the insertion of all sets and excess cement removal, each of their sides were cured (Valo Cordless, Ultradent -Utah, USA) for 40 s. Photograph 1 shows the eleven laminates prior to removal (**Figure 1**).

Figure 1. The initial photograph of teeth.

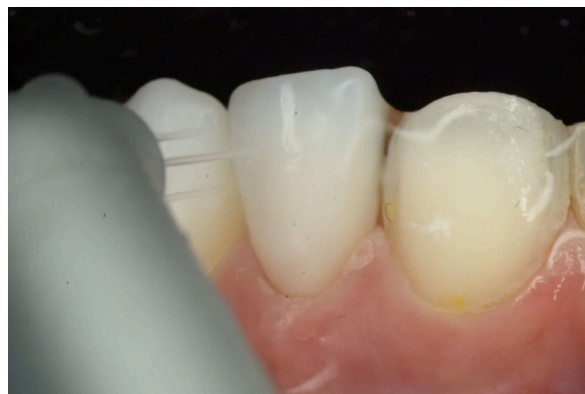
Figure 2. Laser Er-Yag debonding laminate veneers.

No anaesthesia was required for the debonding procedure. The Er:YAG laser was used, with 2.940 nm wavelength (LiteTouch - Light Instruments, Yokneam Industrial Zone, Israel) set with the following parameters: 20 Hz, 250 mJ, and 5 W, with water/air spray irrigation performed with the laser device existing syringe. The application was initiated with 1 min 30 sec duration, with sinuous movements along the laminate surface and in a perpendicular position along the tooth axis, 5 mm distant from the tooth, followed by a lever movement with the resin spatula. In case the ceramic laminate did not detach, one more minute of laser application was performed and another debonding attempt with the spatula was made. **Figure 2**, shows the moment of removal with the laser in position (**Figure 2**). After the debonding, a verification to check for remaining cement was made, both on the tooth and on the veneer, as well as checking the veneer for cracks and its integrity (**Figure 3**).

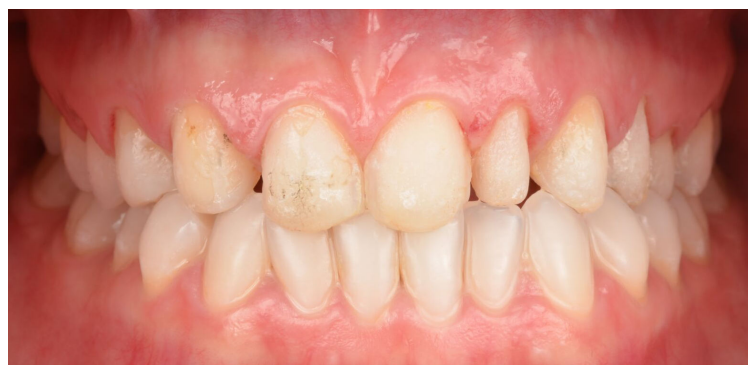
Figure 3. Photograph of the exact moment after removal.

The piece's thickness was verified in three parts (cervical, medium, and incisal) with the use of a thickness gauge. The overall time of each element, integrity, and the presence of cracks were also analysed using a microscope (Zeiss-Oberkochen, Germany) (Table 1).

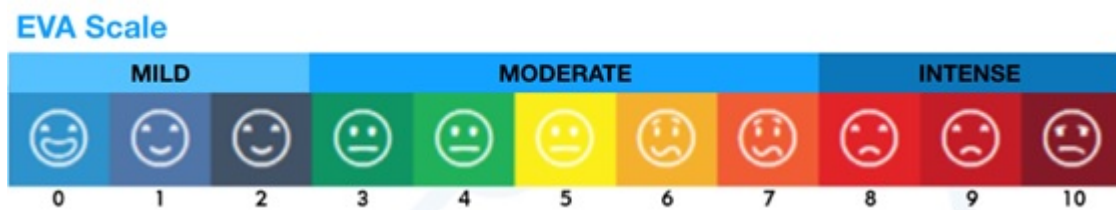
For comfort verification regarding the ceramic laminates debonding with Er:YAG laser, the patient was questioned regarding sensitivity after the debonding of each veneer, and the response was graded as per EVA parameters (Figure 4). The patient reported no sensitivity during the procedure for all elements and total debonding procedure. The answers varied from 1 to 2 for the ceramic laminate veneer debonding with Er:YAG laser.

Figure 4. EVA scale, comfort scale for procedure.

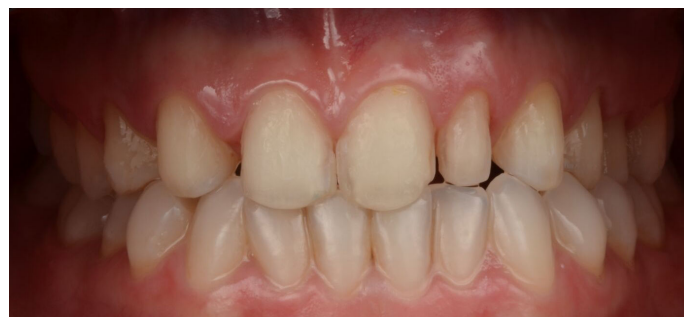
Figure 5. Photograph after reparing the remaining structure.

After the debonding, the elements were prepared with fine and extra-fine diamond tip burs (881F, 881EF, and 859EF - KOMET Besigheim, Germany) contra-angle handpiece 1:5 (Sirona, Salzburg, Austria), finishing and polishing with rubber tip burs (EVE - Keltern, Germany) with 1:1 contra-angle handpiece (Sirona, Salzburg, Austria) (Figures 4 and 5).

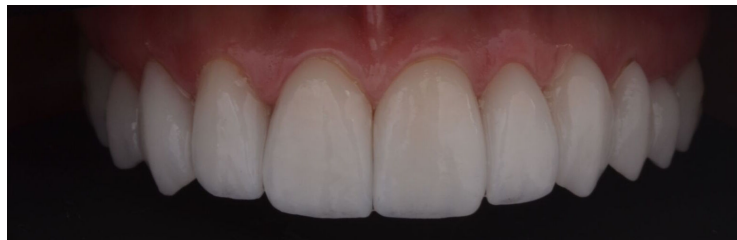
Figure 6. Final Photograph of teeth.

The impression-taking was performed using addition silicone (Virtual - Ivoclar Vivadent - Schaan, Liechtenstein) in two steps, with the insertion of retraction cord (000 - Ultrapack - Ultradent, Utah, USA). Eleven ceramic laminate veneers were

produces, which consisted of pressed lithium disilicate, colour W1, HT pressing ingots (Rosetta - Sro Paulo, Brazil - Hass, Gangwon-do, South Korea) and cemented with light-curable cement (Variolink Esthetic - Ivoclar Vivadent - Schaan, Lienchtenstein). The etching was performed with 5%-hydrofluoric acid (CEtching - BM4, Santa Catarina, Brazil) for 20 s, followed by rinsing with water, decontamination in the ultrasonic cleaner with alcohol at 70% for 5 min and water rinsing. After drying of pieces, silane was applied (Primer Monobond N Universal - Ivoclar Vivadent Schaan, Lienchtenstein), followed by warm air jets for 1 min on each side of the drying device of ceramic laminates. So, a thin layer of a universal adhesive (T-Tric N-Bond Universal - Ivoclar Vivadent Schaan, Lienchtenstein) was applied, followed by air jet, but not light-cured.

On the tooth, 20 sec 37%-phosphoric acid conditioning was performed (Ultradent - Utah, USA), followed by water/air pray cleaning. After drying with absorbent paper, the universal adhesive was used (Tetric N-Bond Universal - Ivoclar Vivadent, Schaan, Lienchtenstein), after light air jet drying. The soft coloured light-curable cement (Variolink Esthetic - Ivoclar Vivadent, Schaan, Lienchtenstein) was applied on the ceramic laminate, and the set was positioned. After the insertion of all sets and excess cement removal, each of their sides were cured (Valo Cordless - Ultradent, Utah, USA) for 40 s.

After complete light-curing, the excess cement was removed with the assistance of microscopic magnification (Pro-Ergo Zeiss Oberkochen, Germany) and a scalpel blade (**Figure 6**).
